HOUSATONIC RIVER BASIN
DERBY, CONNECTICUT

LOWER ANSONIA RESERVOIR DAM CT 00027

PHASE I INSPECTION REPORT NATIONAL DAM INSPECTION PROGRAM

SEPTEMBER, 1980

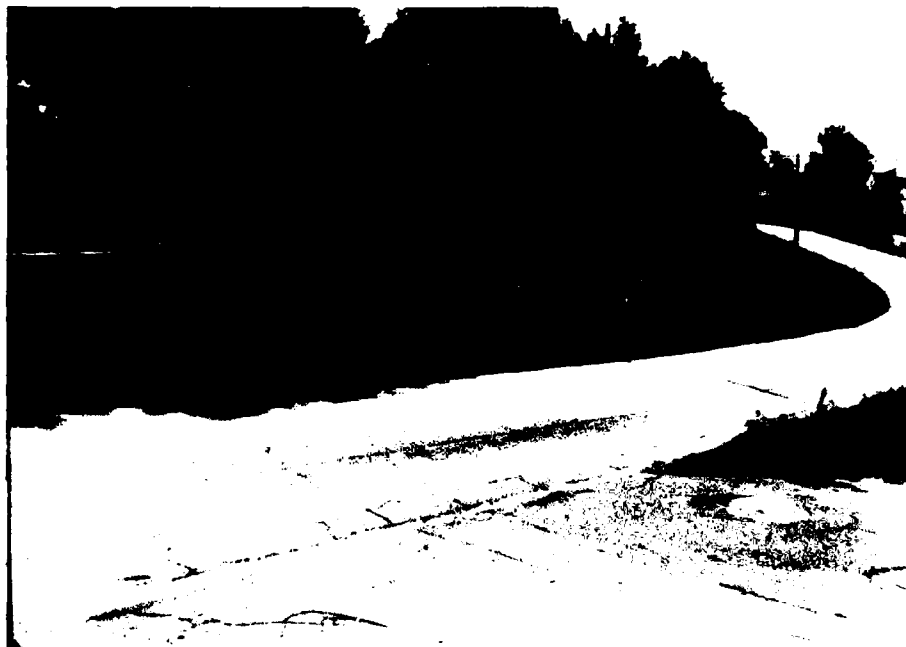
Downstream Slope - The downstream slope appears to be uniform in inclination and no evidence of sloughing or surface erosion was noted. However, much of the slope is heavily brush covered and difficult to inspect, especially to the left of the spillway (Photo 2, Overview Photo). A wet condition immediately to the left of the left spillway training wall is indicated by the presence of reeds and swamp grass in this area (Photo 3). This wet condition could be the result of surface runoff from the street along the toe of the dam and/or minor seepage through the dam. Vegetation is sparse in a few places on the downstream slope of the right side of the embankment, due to disposal of dead branches and grass cuttings on the slope. The dry laid stone wall and fence along the toe of the dam are in fair condition.

Photo 2 - Downstream slope and top of right side of dam (8/8/80).

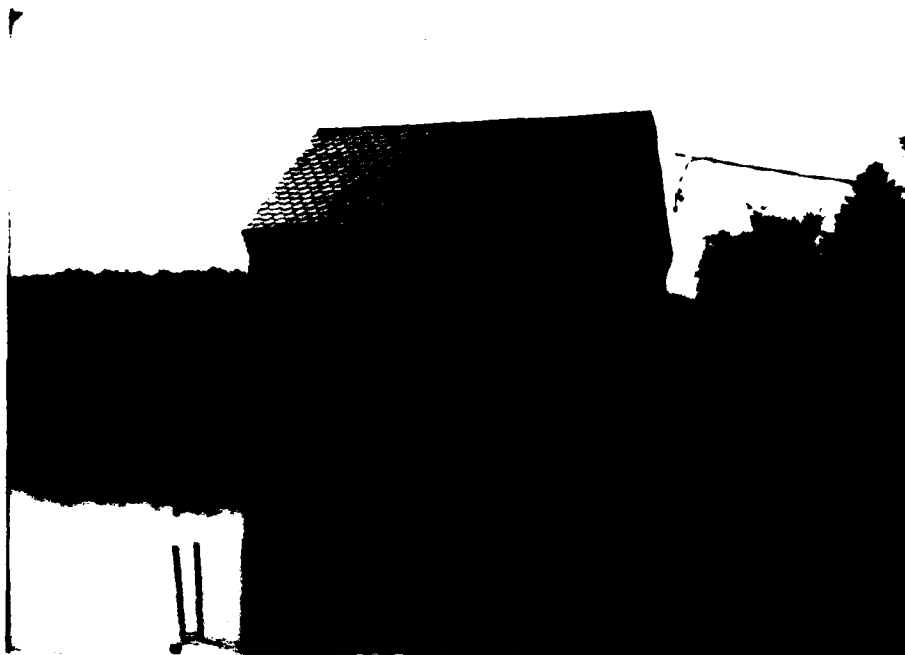
c. Appurtenant Structures - The gatehouse, intake chamber, and operating facilities appear to be in good condition. Some areas of the masonry substructure were resurfaced with mortar which does not exhibit any cracking or spalling. Leaching of some of the mortar joints of the superstructure brickwork and deterioration of a few bricks was noted (Photo 5). The operating facilities for the supply main and the intake chamber drain pipe appeared to be well lubricated and are operable (Photo 6). The gate screens and the steel brackets in which they slide are in poor condition, exhibiting considerable corrosion. The wood deck over the intake chamber is in good condition. The gate valve stem for the low-level outlet, located 35 feet to the left of the spillway, is corroded. The owner reports that the handle for this gate valve is kept in the gatehouse and that the gate is operable.

Photo 5 - Gatehouse (8/8/80).
